Manhole Inspection Summary

Manhole # S49W1_007MH

Location Address: **3227 Sun St.**

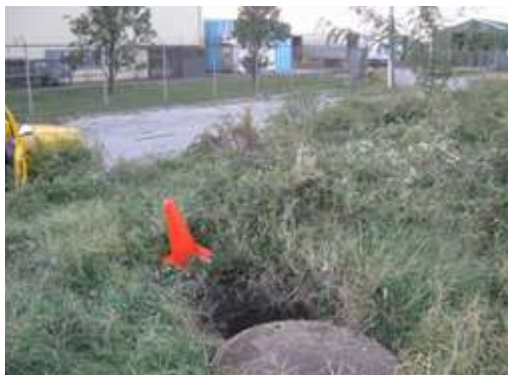
Location View

Across 3230 Sun St.

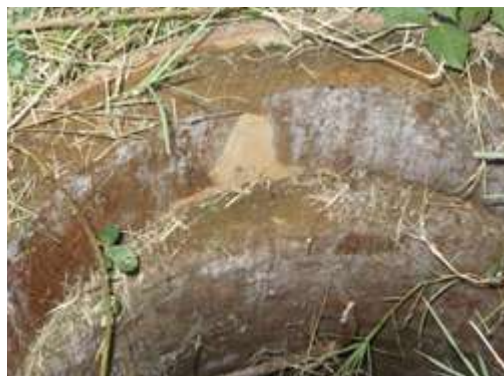
Defect 1

Offset: **3** (in.)

Frame Offset

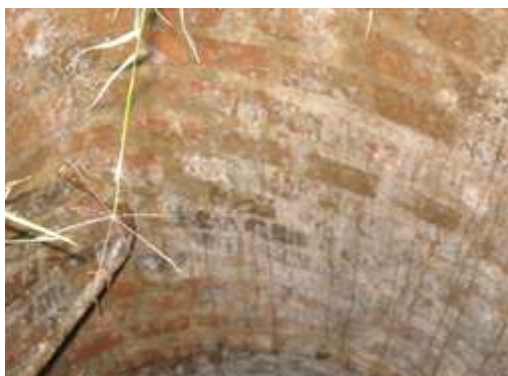
Defect 2

Infiltration: ☐ None ☒ **Joint** ☐ Cracks ☐ Mortar ☐ Roots ☐ Wall

Leakage

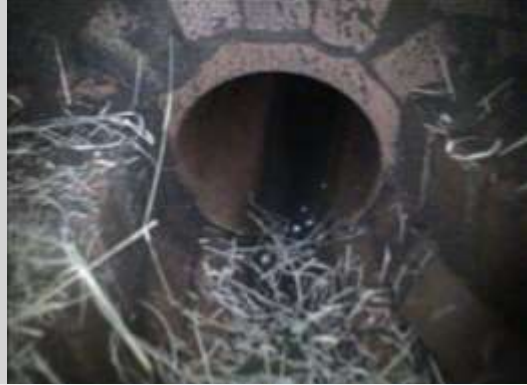
12 O'Clock Outflow

8 in. Circular Gravity Sewer
Pipe Out @ 12 O'Clock

Pipe Height: **8.4** (in.) Rod and Bar (Angled)
Pipe Material: **Clay** ☐ Pipe Lined
Invert Depth: **13.10** (ft.) Flow Characteristics: **None**
Deposits: ☒ None ☐ Mud ☐ Sludge ☐ **Debris** ☐ Grease
Silt Depth: (in.) Deposits Extent:
Infiltration: **None** Pipe Seal Cond: **Sound**

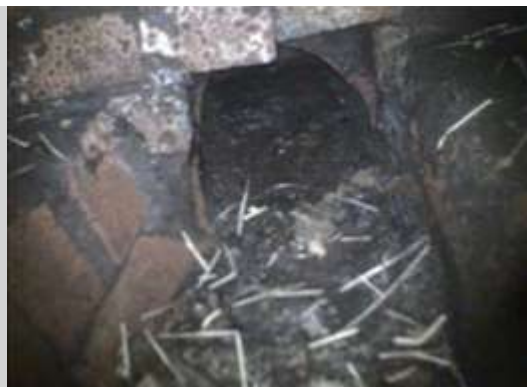
3 O'Clock Inflow

6 in. Circular Gravity Sewer
Pipe In @ 3 O'Clock

Pipe Height: **8.4** (in.) Rod and Bar (Angled)
Pipe Material: **Clay** ☐ Pipe Lined
Invert Depth: **12.60** (ft.) Flow Characteristics: **None**
Deposits: ☐ None ☒ **Mud** ☐ Sludge ☐ **Debris** ☐ Grease
Silt Depth: **2** (in.) Deposits Extent: **Medium**
Infiltration: **None** Pipe Seal Cond: **Sound**

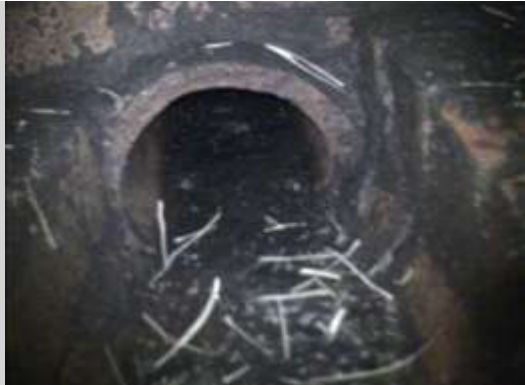
5 O'Clock Inflow

Deposits: ☐ None ☐ Mud ☐ Sludge ☒ **Debris** ☐ Grease

Silt Depth: **1** (in.) Deposits Extent: **Light**

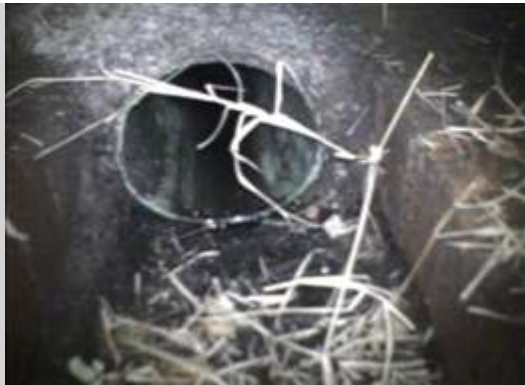
9 O'Clock Inflow

Pipe Material: **PVC** ☐ Pipe Lined

Deposits: ☒ **None** ☐ Mud ☐ Sludge ☐ Debris ☐ Grease
